Stream Team Report

Mowry Brook Marlborough, Massachusetts Study Conducted June-July, 2007

Submitted
November 10, 2007
By Jennifer Boudrie
Jen@GreenMarlborough.org
T 508-481-0569

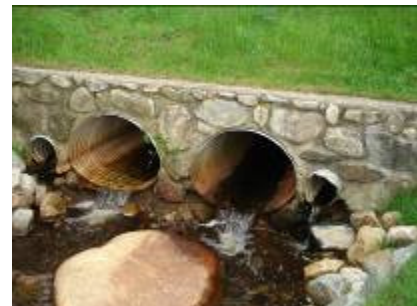
Near Stow Road the stream flows through a driveway culvert. Debris collects there and is slowly eroding the driveway. The culvert is too small during floods.

From here the stream flows into a pond with a dilapidated bridge here. The stream continues beyond the pond and passes a few more houses. It goes under Stow Road, over rip rap, and under Concord Road to the golf course. The culvert at Concord Road is too high for upstream aquatic/wildlife migration.

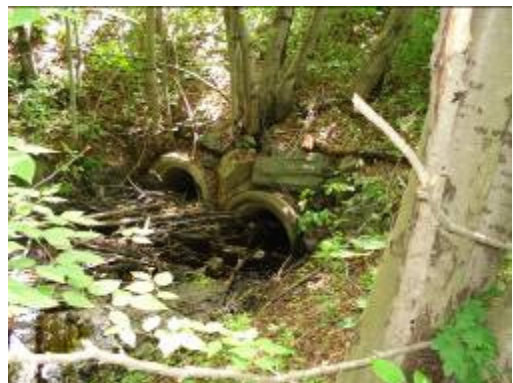
Near the party trash area is this culvert on Kings Grant Road which has some natural debris that may clog the culvert at some point.

Debris is found at Mowry Brook near Kings Grant Road. There are sticks in the stream that may block the culvert and party trash is nearby in the woods.

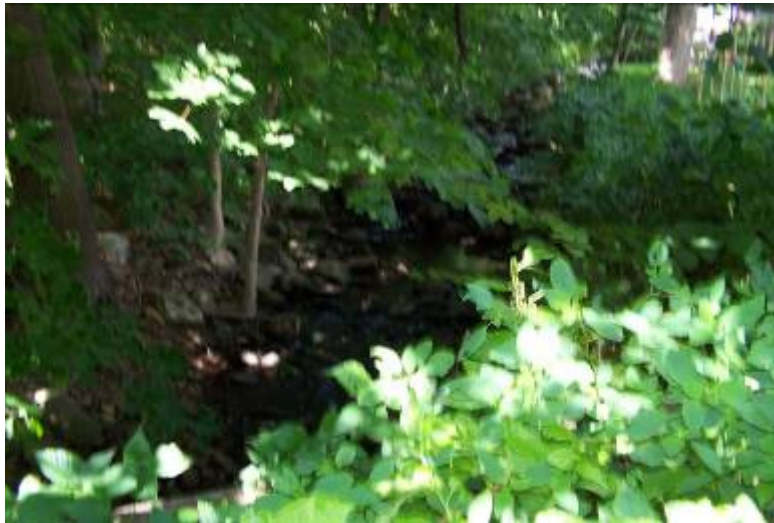
We approached the segment of this stream from this point, since access between Route 20 and down Phelps to this spot was inaccessible due to extremely dense vegetation. The left bank at this point (only) was made up of a precipitous boulder structure; at the top of it was an abutter's garden but it had wooden rails that seemed to prevent run off down into stream. Right side was a sloped wooded area. A lawn abutted it about 10 yards back. Some but, not much litter. One small riffle; otherwise water moved on down easily over the rocks to the well exposed culvert.

(Photo taken August 18, 2007) notice top right neighbor's garden area

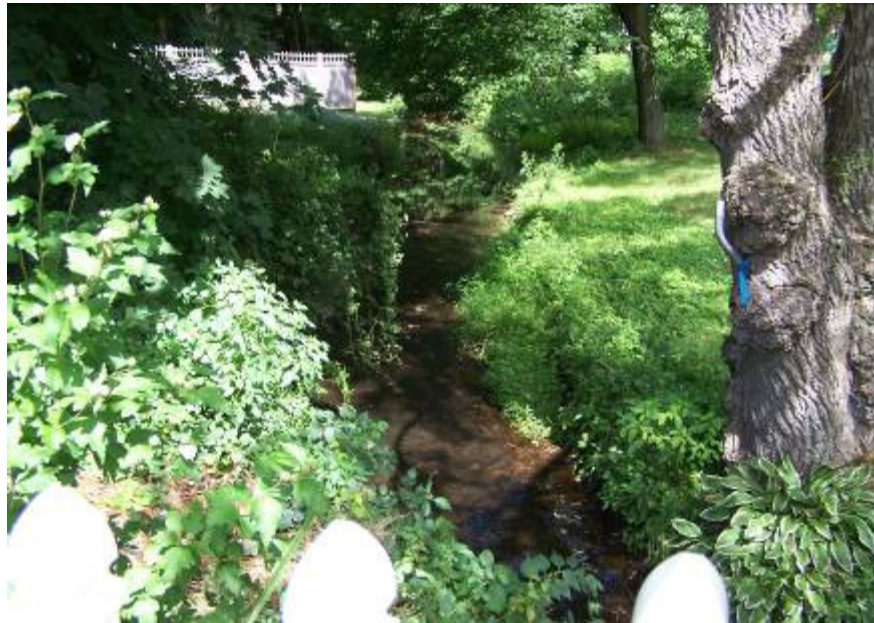
(Photo taken August 18, 2007) Farm Road

The stream, just before it crossed under Farm Road was surrounded by dense vegetation. Signs of plants probably planted by neighbors. Area back upstream becomes very wooded. Went into Kane School yard to see if could see the stream further up. We were able to see a stream, muddy, flowing through a very heavily shrubbed and wooded area – rear ball field at Kane. There was a sign of run off into wooded area (man made gravel “ditch”). Many vines in this area too. This water seemed to come from two culverts side by side on the hilly area NW side of the school. Water ran smoothly and clearly through culverts. Not sure if this is “our” stream further up but rather maybe a branch from more easterly down Route 20.

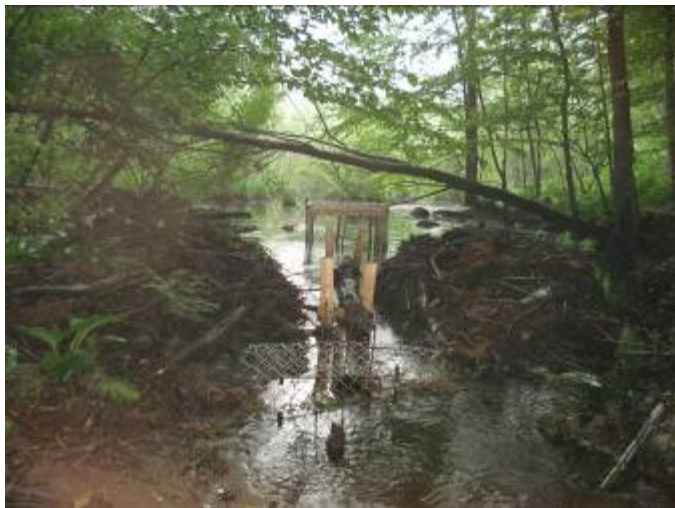
Beaver Dam North of Spoonhill Road

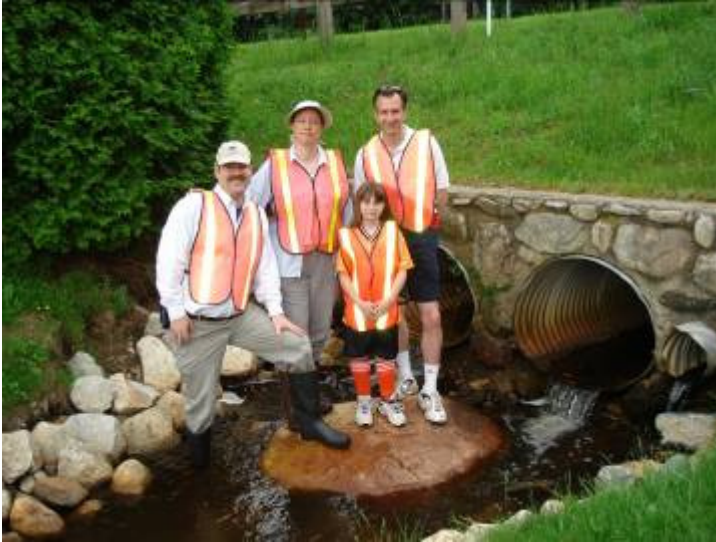
Stream Team by culvert south of Concord Road

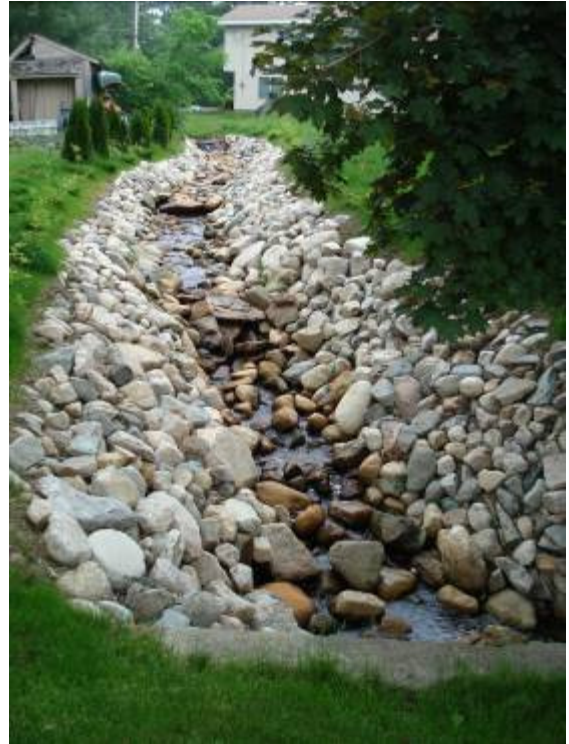
Riprap between Stow and Concord Roads
